# SEDIMENT INVESTIGATION REPORT

PREPARED FOR:  
Mundelein Park & Recreation District

PREPARED BY:  
ILM ENVIRONMENTS  
April 5<sup>th</sup>, 2024

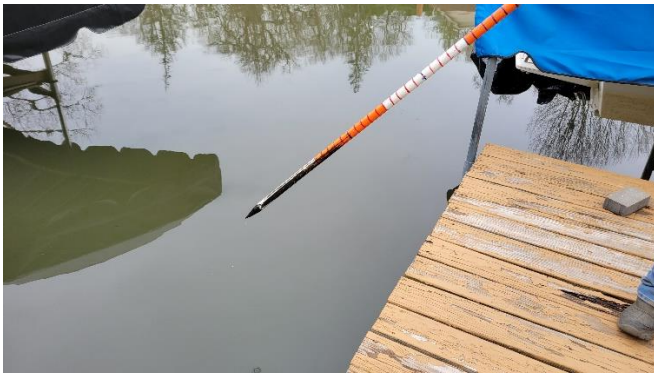
**Photo 1.** Sediment actively being probed (3/25/24).

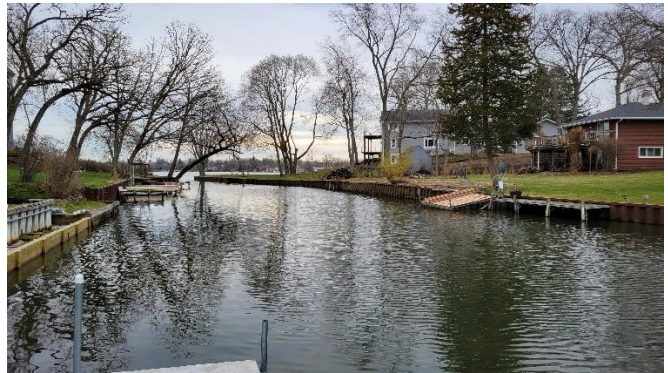
- Very few aquatic plants were observed, as expected based upon the timing of the visit.
- Water levels were at NWL, and some inflow was noted at each inlet.
- Much of the shoreline would be considered as experiencing moderate to severe erosion.
- The site exhibited obvious scouring patterns from wave-based erosion, many shoreline protections were in poor shape.
- Projects being conducted on the shoreline are unprotected and leading to additional sediment entering the lake.
- The channel had an average water depth of 2.2 feet. The average sediment thickness was 1.4 feet, and the channel is approximately 37% full of sediment.

**Photo 2.** View of the Channel.

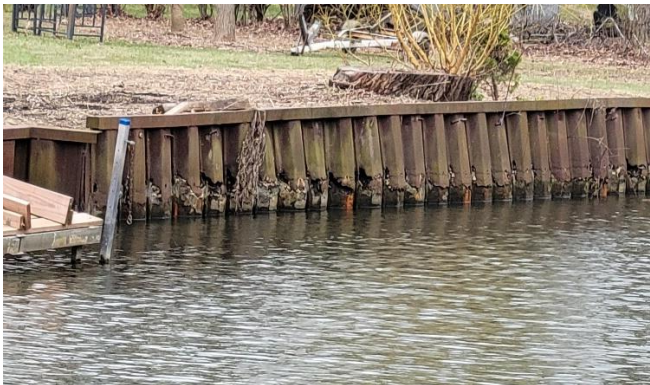
**Photo 3.** Example of failing seawall on the channel.

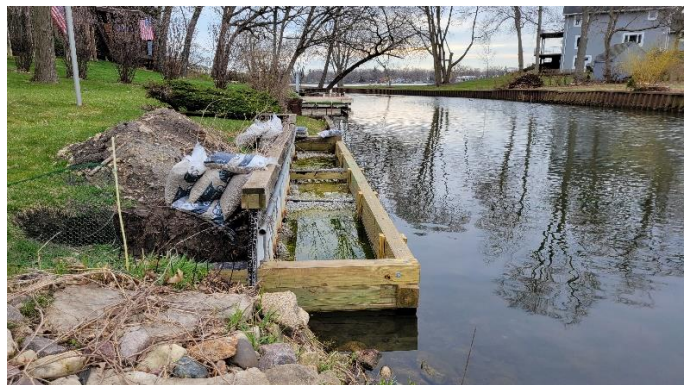
**Photo 4.** Shoreline project with exposed sediment piles, excavated soils, construction debris which impact overall channel and lake health.

Most of the shoreline around the channel includes scoured and degraded slopes with limited erosion control. This adds to sediment in the channel. Numerous projects seem to be in progress along the shoreline. These activities require permitting and regulation because they often lead to sediment entering the lake. Based on visual assessment of the in-progress projects, it is likely property owners are conducting these activities without proper permitting in place through the county.

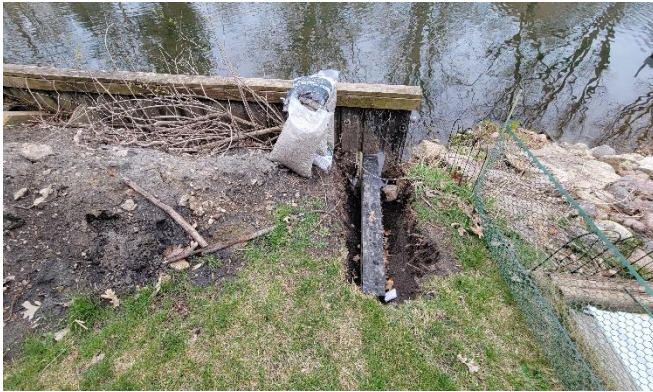
**Photo 5.** Closer view of exposed soils.

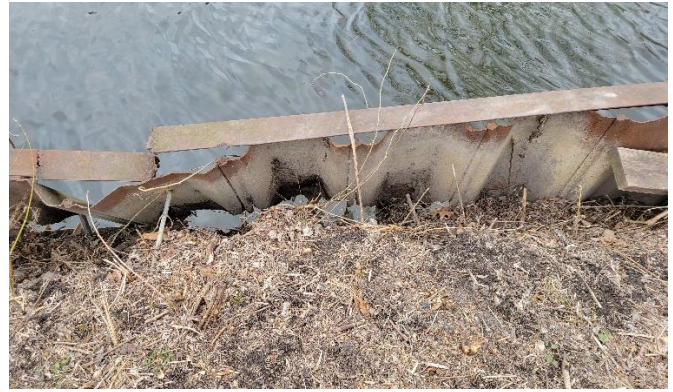
**Photo 6.** Seawalls no longer offer shoreline protection.

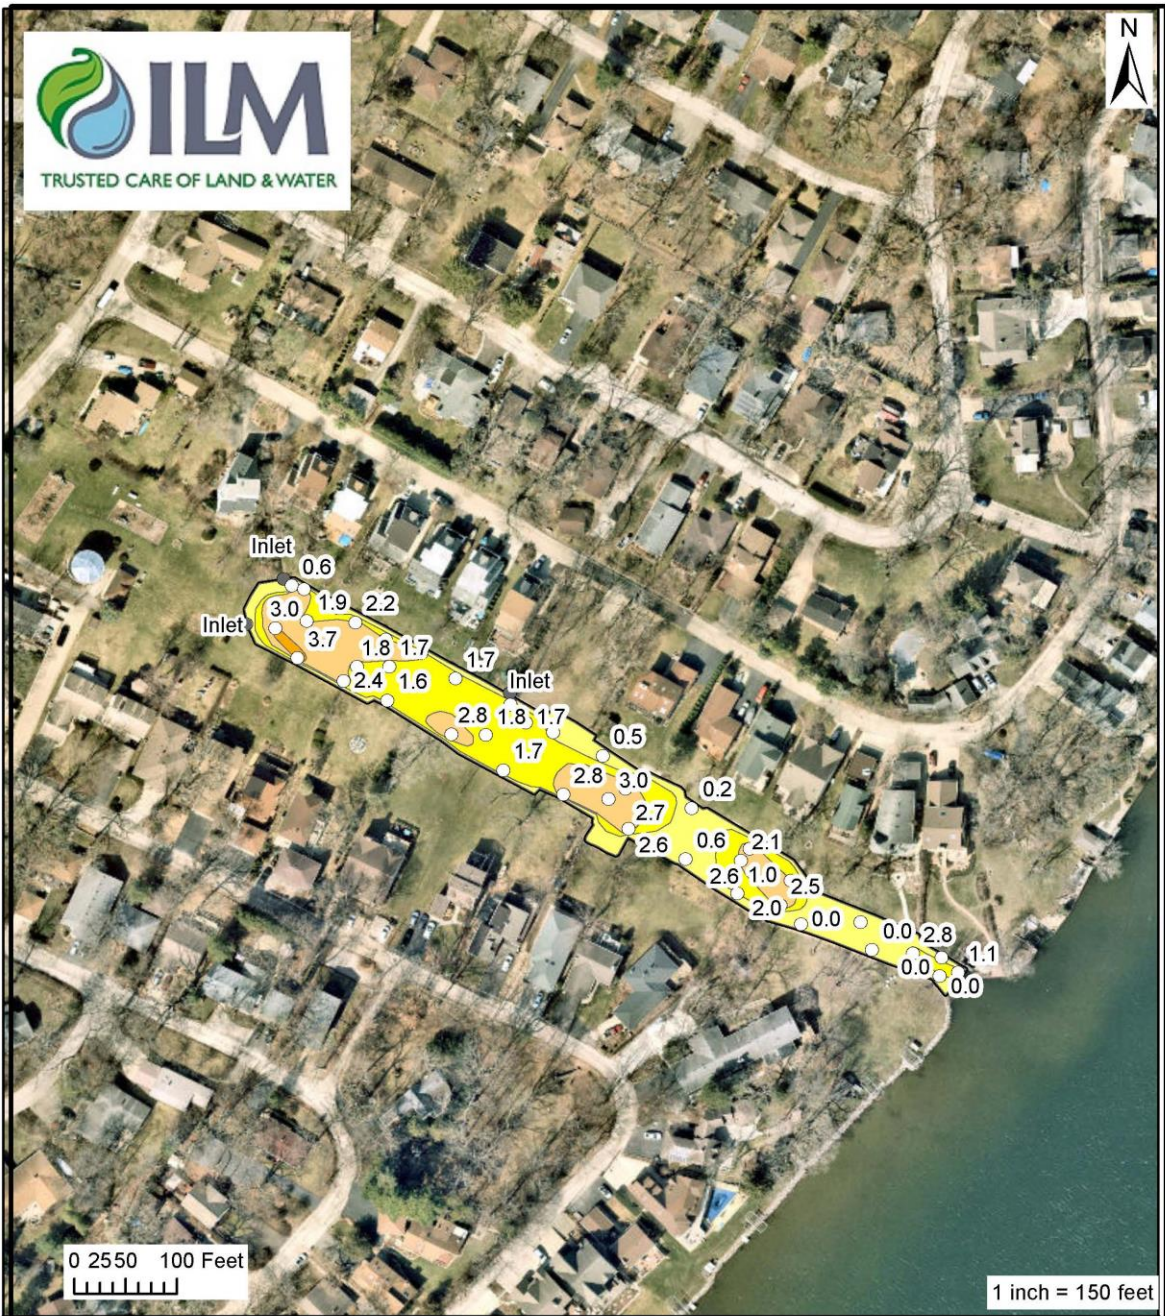
**West Channel of Diamond Lake Sediment Map**  
**19449 Forest Lane**  
**Mundelein, IL**  
**March 25th, 2024**

The results for the sediment mapping survey can be found in Table 1 below. To determine percent full of sediment, we divide the average sediment volume by average total volume. The West Channel of Diamond Lake was 37% full of sediment (Table 1). The maximum sediment thickness recorded was 3.7 feet. The average water depth was 2.2 feet. If the entire area was dredged of all sediment, the average water depth would increase by 1.4 feet.

The channel exceeds the recommended 30% cutoff (currently 37%), indicating dredging should be conducted in the channel. It is likely this sediment is leading to nuisance algae growth and impacting navigability of the channel for boat traffic as well.
