# SEDIMENT INVESTIGATION REPORT

PREPARED FOR:  
Mundelein Park & Recreation District

PREPARED BY:  
ILM ENVIRONMENTS  
April 5<sup>th</sup>, 2024

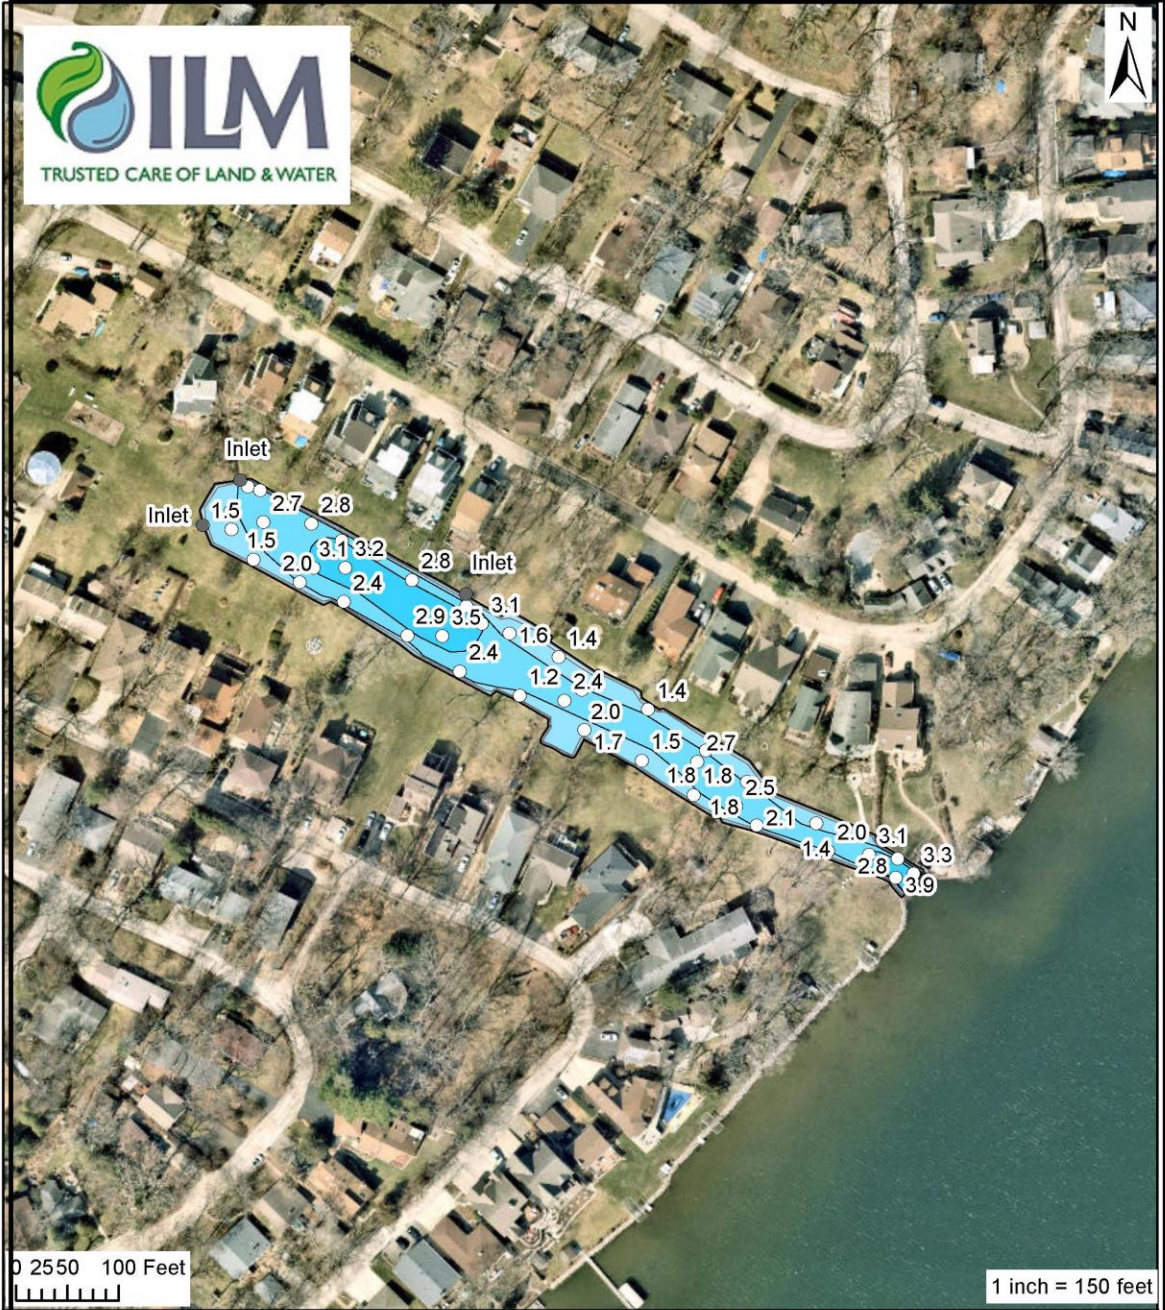
**West Channel of Diamond Lake Sediment Map**  
**19449 Forest Lane**  
**Mundelein, IL**  
**March 25th, 2024**

This map combines data from the bathymetric map showing water depth and the sediment thickness map to show the depth from the surface of the water body to “hard bottom”. If all sediment present was removed, these numbers represent how deep the water body would be.
